# Leith Walk cycling infrastructure analysis

## Summary of key findings

AECOM were commissioned by the City of Edinburgh Council to record observations and analyse video monitoring data for new cycling infrastructure on Leith Walk. Videos were recorded and analysed to assess the operation and safety of three elements of new infrastructure:

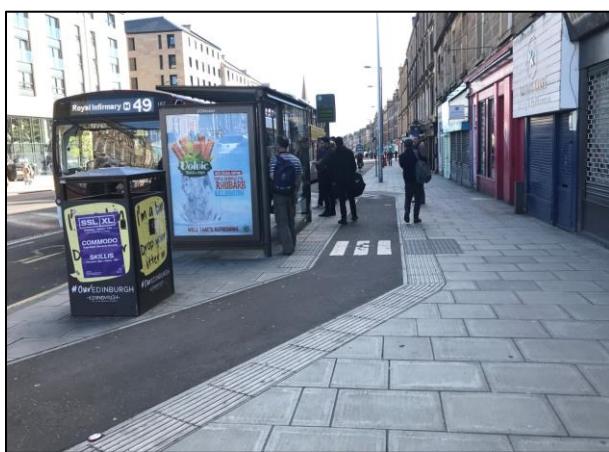
Figure 2 - Bus stop bypass (Leith Walk Southbound)

A bus stop bypass, also known as a 'floating bus stop', is an arrangement that involves a cycle track running behind the passenger boarding area at a bus stop, between an island and the pavement. At the bus stop bypasses on Leith Walk the cycle tracks are at the same level as the pavement and are segregated by a single row of corduroy paving on either side of the cycle track. Uncontrolled crossings are provided to assist pedestrians crossing the cycle track between the pavement and island, with two rows of tactile paving and informal Zebra crossing markings being provided.

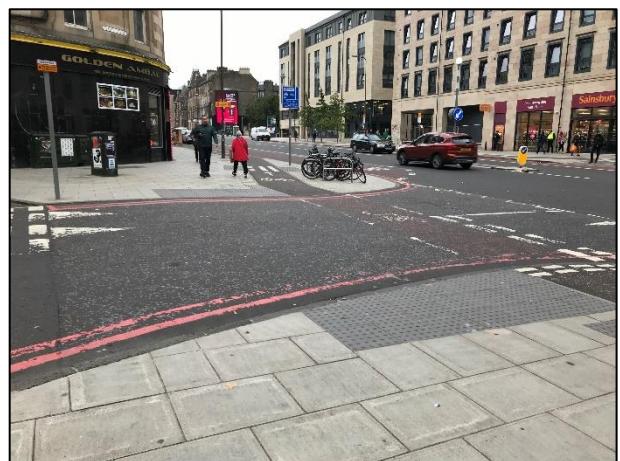
Figure 3 - Cycle priority crossing across Albert Street

Where a cycle track crosses a relatively lightly trafficked side road junction, the cycle track can be continued across and given priority over the side road. The crossing is generally sited on a flat-topped road hump to ensure low vehicle speeds and provides pedestrians with a crossing point. Road markings are used to instruct vehicles to give way to the cycle track and pavement on approach.

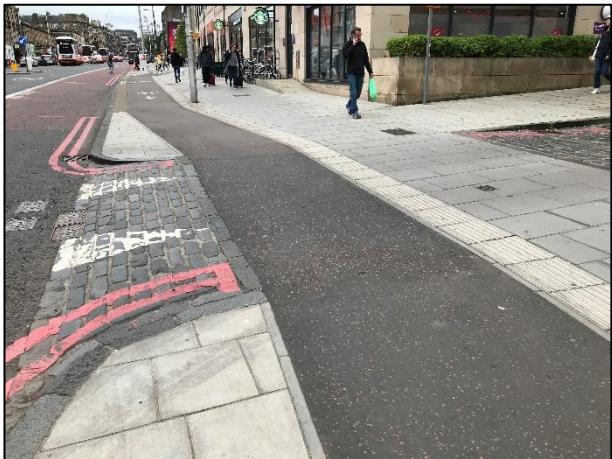
Figure 4 – Continuous footway across Middlefield

A continuous footway is an uninterrupted pavement that extends across a side road junction. They are most suitable at junctions with low levels of vehicular traffic turning in and out of them. Continuous footways should not contain any change in design and materials or breaks that might give the visual impression of priority to motor traffic. The drivers / riders of motor vehicles should treat this area as part of the pavement that they have to cross.

The section of pavement crossing the side road should also be at the same level as the rest of the pavement, meaning drivers / riders have to ramp up and over it, helping to keep vehicle speeds low.

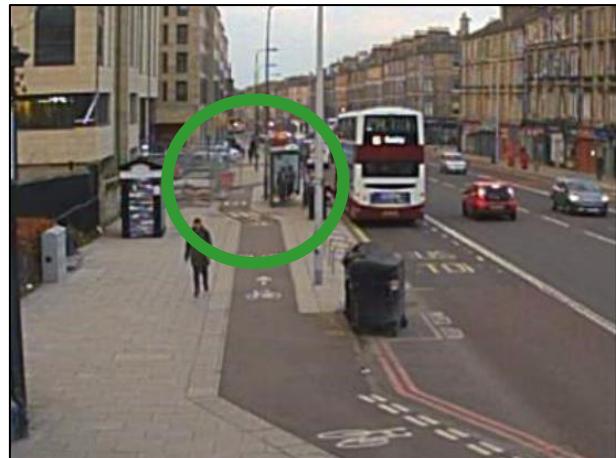
Figure 5 - Narrowing of western pavement on Leith Walk

The total number of pedestrians entering the cycle track at the northbound bus stop in November 2018 was affected by the pavement on the west side of Leith Walk being temporarily narrowed due to road works, which meant that the number of pedestrians entering the cycle track rose to 11,788

from 4,320 and 3,142 in November 2017 and May 2018 respectively.

Discounting the data from the November 2018 data set that was affected by the temporary pavement narrowing, the data indicates that the number of pedestrians entering the cycle track at the bus stop bypasses has been trending downwards, while the number of pedestrians increased between November 2017 and November 2018.
